TECHNICAL REPORT ARCCB-TR-92034

EDDY CURRENT INSPECTION OF GUN TUBES

DAVID CONCORDIA

JULY 1992

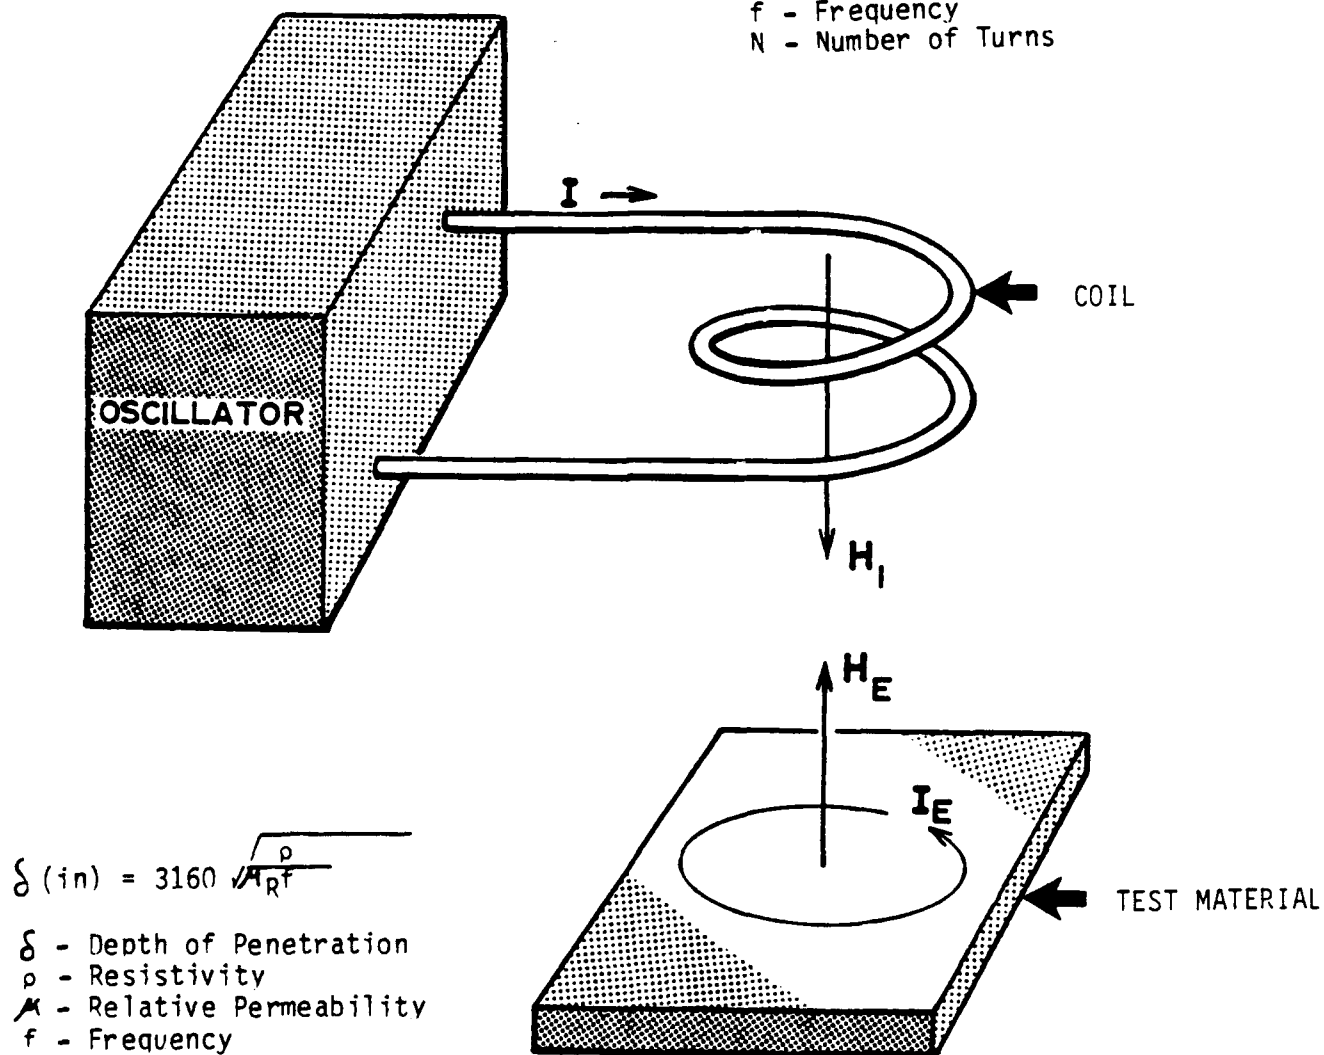
Figure 1. Basics of eddy current inspection.

The principle behind eddy current inspection is depicted in Figure 1. The oscillator represents the electronics used to produce an AC voltage across the coil at a given frequency. "I" represents the electric current flowing in the coil at one instant in time. The current in the coil produces a magnetic field, the strength of which is proportional to the number of coil turns (N) multiplied by the current. The magnetic field produced by the current is shown in Figure 1 by the arrow labeled H_1 (magnetic field strength of the coil). This creates a magnetic flux that causes currents to flow in the test material located adjacent to the coil. These currents, because of their tendency to flow in a circular path, are called eddy currents and are produced by magnetic induction. The eddy currents flowing in the material labeled I_E , produce a magnetic field counter to the original magnetic field. As shown in Figure 1, since the magnetic flux is a function of the voltage (E), frequency (f), and number of coil turns only, then the magnetic field strength of the coil must increase to maintain the flux. The increase in magnetic field strength is produced by an increase in the current. A crack in the test material decreases the magnitude of the eddy current, because the current must now travel around the crack resulting in a decrease in the magnetic field strength of the eddy current and the magnetic field strength of the coil current. The decrease in the magnetic field strength of the coil is produced by a decrease in the value of the current in the coil. The decrease or change in the current can be readily measured and is a way to detect cracks in the test material. The depth to which the eddy currents penetrate the test material is shown in Figure 1. Since the depth is inversely proportional to the relative permeability of the material, the currents do not penetrate nearly as deep in steel as they do in a nonmagnetic material such as aluminum. Thus, eddy current inspection of magnetic materials is basically a surface inspection.

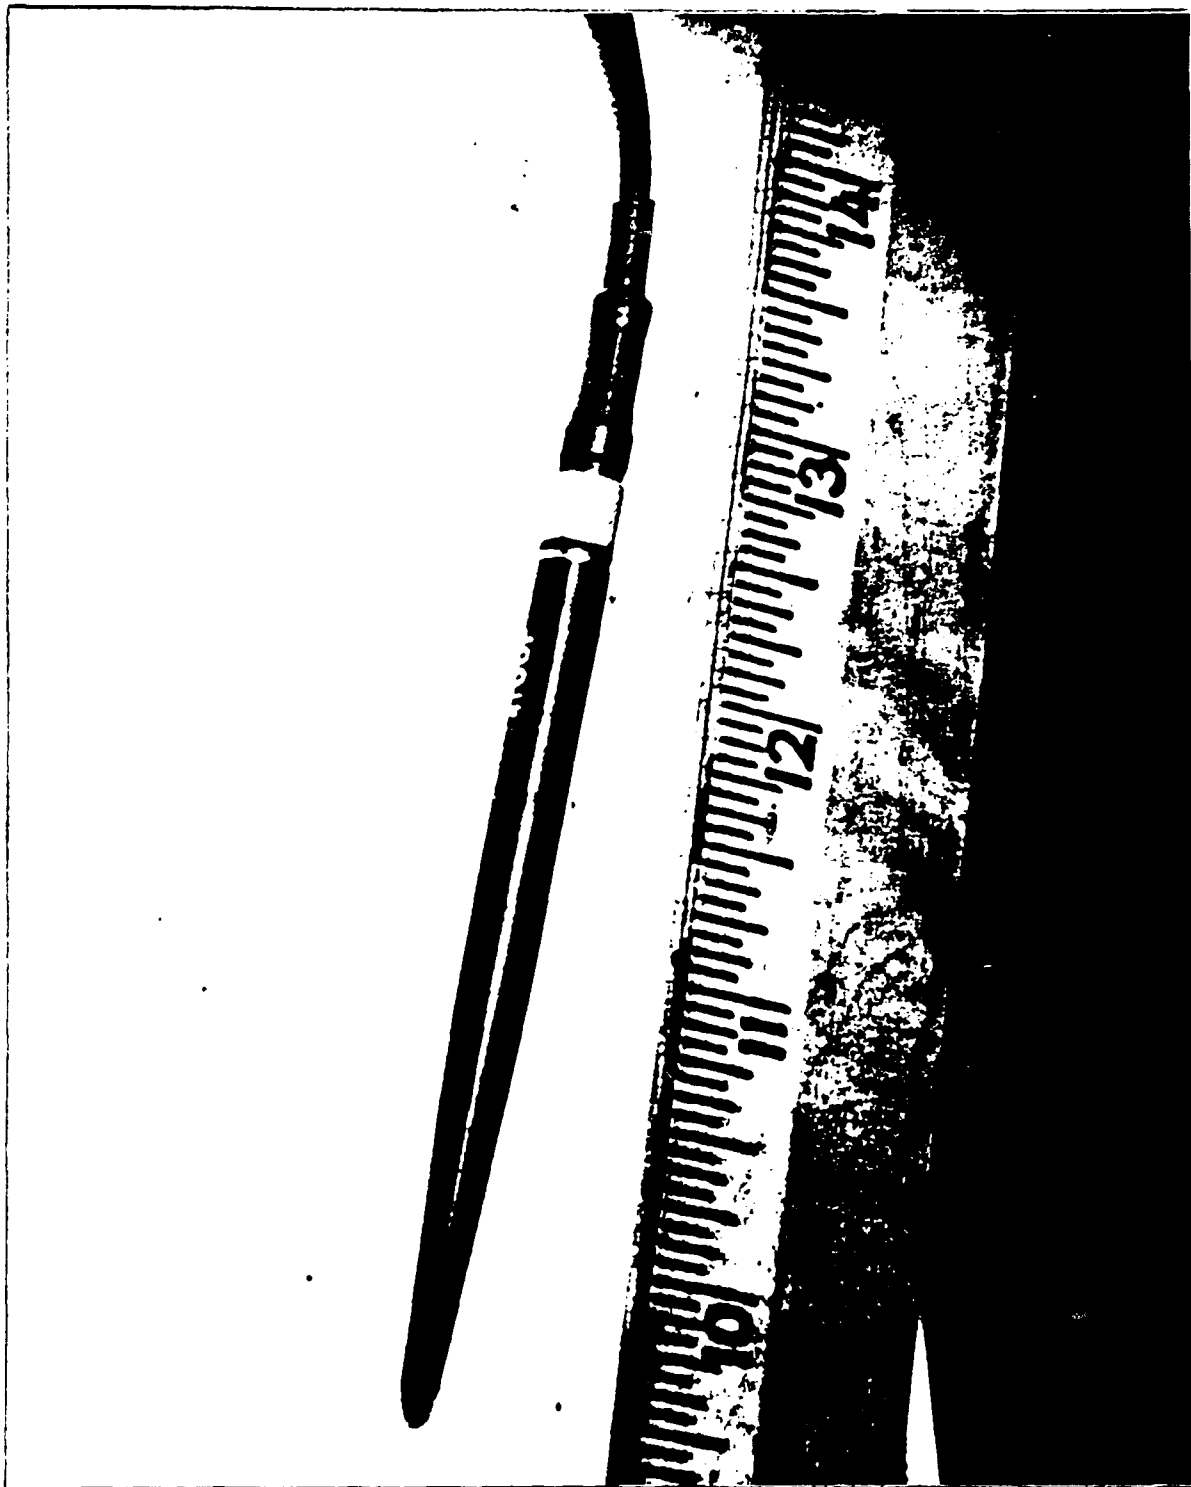
Figure 2. Pencil probe.

To improve the sensitivity, tests were conducted using a small "pencil"-type probe (see Figure 2) using the setup shown in Figure 3. A pencil probe was mounted adjacent to the ID surface of a section of a gun tube. The section of tube was rotated by a motor to produce relative motion between the probe and test surface. The Reluxtrol instrument was used to process the signal from the sensing probe.

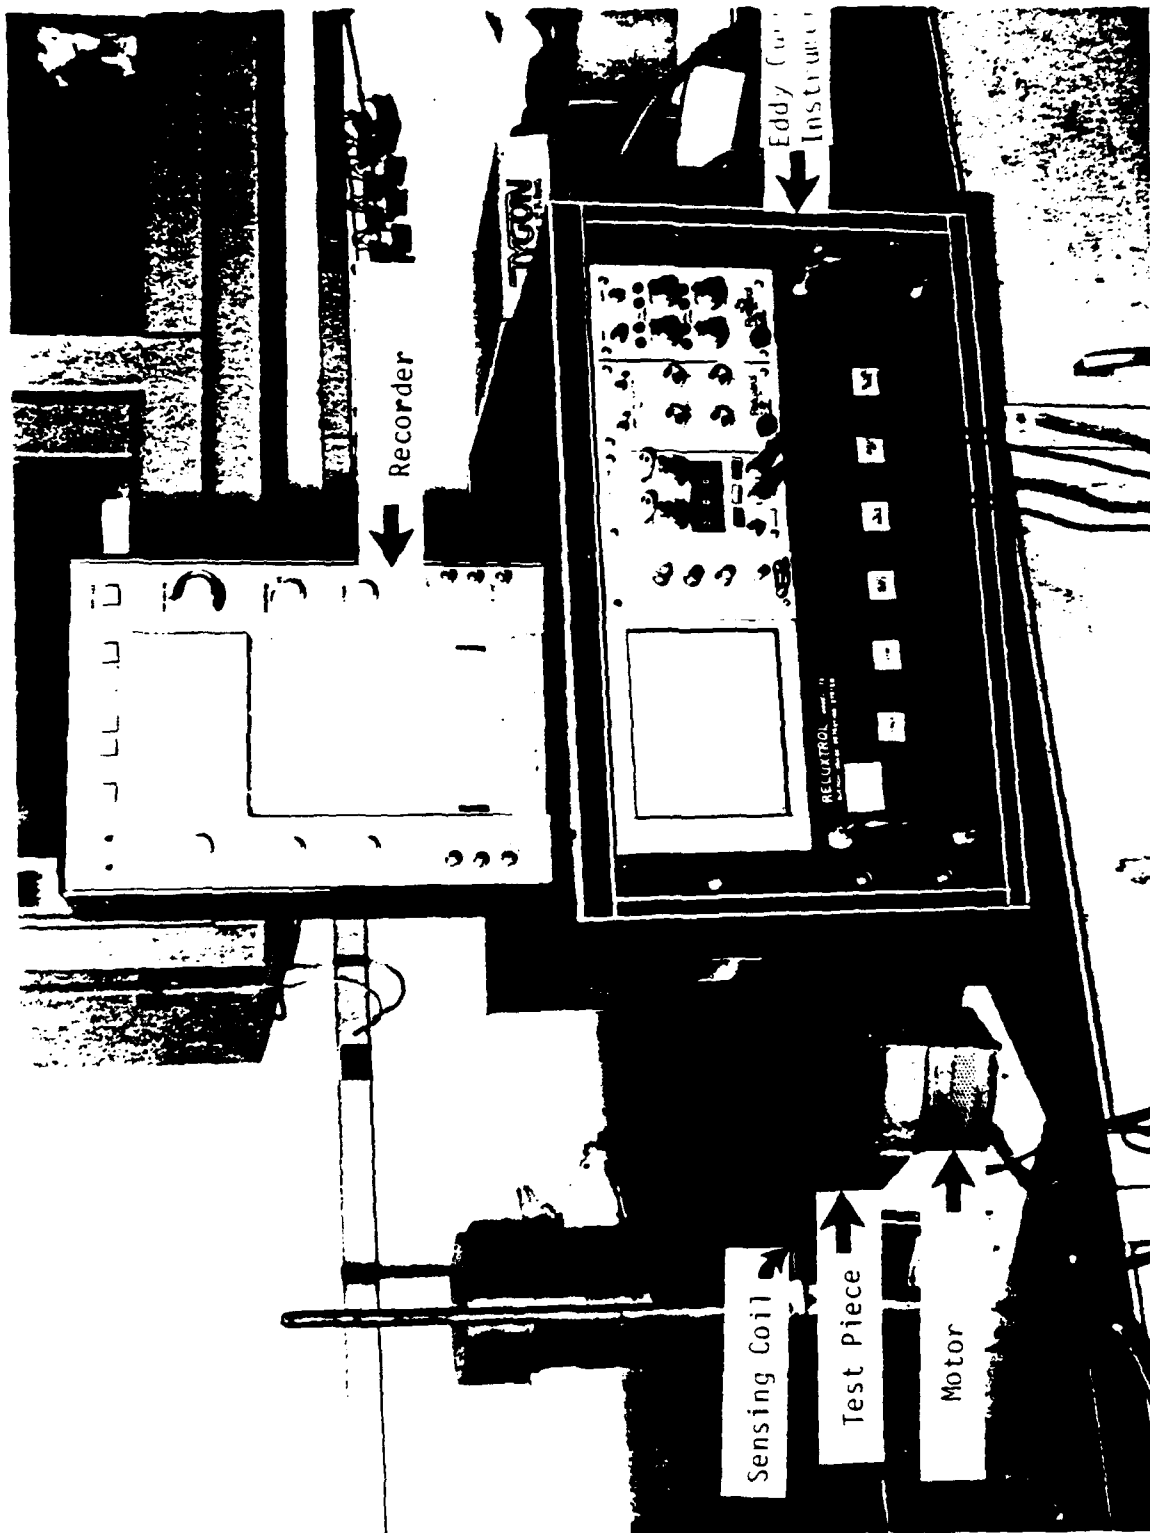
Figure 3. Eddy current test setup with pencil probe.

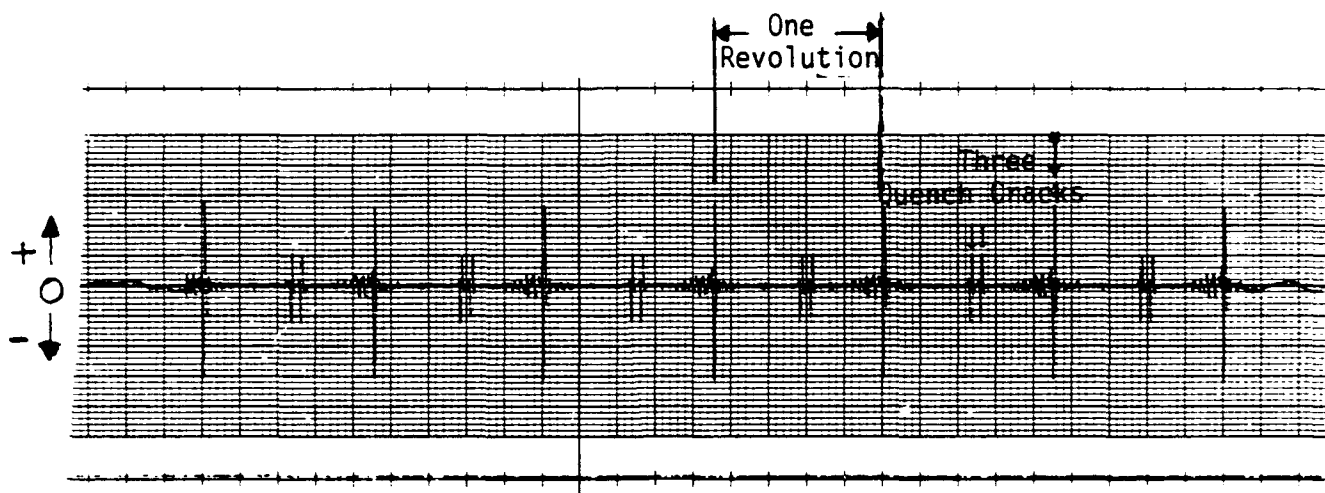
Figure 4a. Recording signal from a 105-mm section containing three quench cracks.

The test results were encouraging. Figure 4a shows the recording from a 105-mm tube section containing three quench cracks: one large crack and two smaller cracks. Figure 4b shows the recording from a 105-mm section with a heavily-scaled ID surface without quench cracks. Both recordings were taken at 100 kHz, 20 mV/division, and a passband filter setting of 10 to 30 Hz. The probe was held fixed as the sample rotated. The recording in Figure 4a shows two closely-spaced quench cracks and a larger quench crack approximately 180 degrees from the smaller ones. Figures 5a through 5c show recordings obtained at three different frequencies: 250, 100, and 30 kHz. As seen, the change in frequency had no significant effect on the signal. Figure 6 demonstrates the effect of filtering on the signal produced. Figure 6a shows the signal produced from a section containing three quench cracks and a scale pocket approximately 0.5 inch in diameter formed when an area of scale separated from the ID surface. The pocket depth is approximately 0.035 inch, and the quench cracks are from 0.1 to 0.5 inch deep. Filtering was set at 3 to 30 Hz passband. The signals in Figures 6a and 6b have been rectified and clipped for a more legible recording. Figure 6b shows the same recording at an increased chart speed to differentiate the wavelength between the quench crack and the scale pocket signal. Figure 6c shows the recording at a passband filter setting of 10 to 30 Hz. The indication from the scale pocket was filtered out. The results of these tests were encouraging at the time, since they indicated that filtering would effectively remove the unwanted indications from scale pockets on the recorder trace.

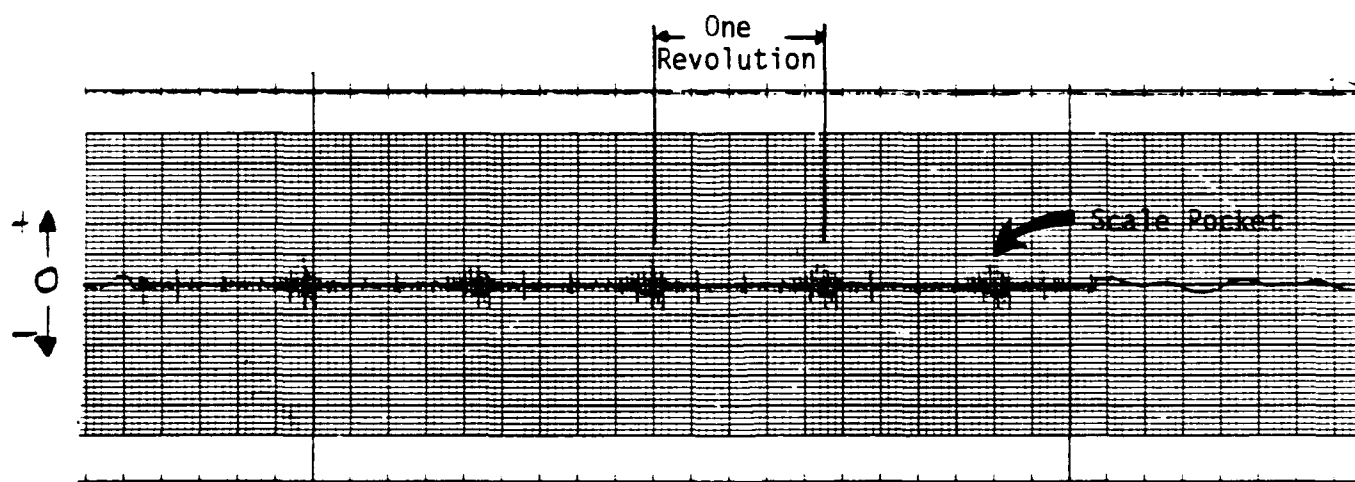
Figure 4b. Recording signal from a 105-mm section with a heavily-scaled surface without quench cracks.

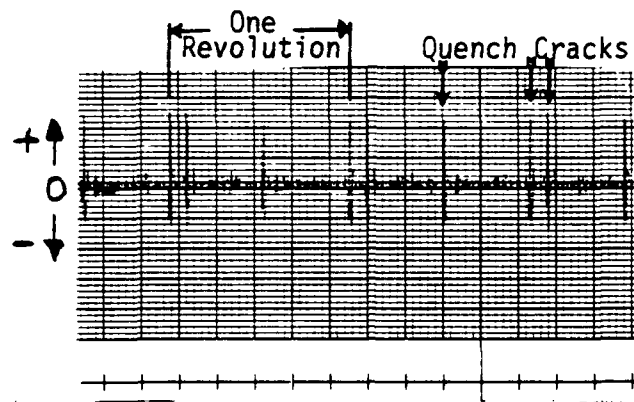
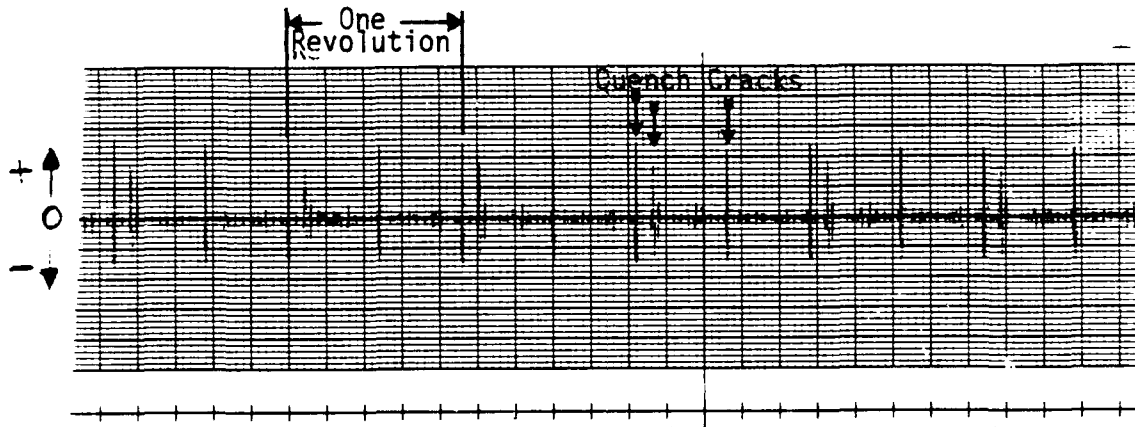
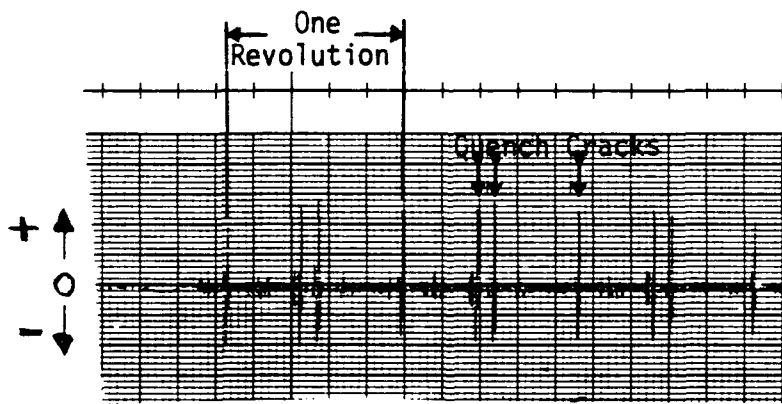
a. 250 kHz signal.

b. 100 kHz signal.

c. 30 kHz signal.

Figure 5. Recording signals from a 105-mm section containing three quench cracks.

- The frequency was not an important factor in determining the quality of signal produced in the 30 to 250-kHz range. Tests conducted below 30 kHz showed a deterioration of the signal-to-noise ratio.
- Filtering effectively reduced the signal produced from surface roughness.
- The pencil probe produced a signal far superior than that from the full diameter coil.

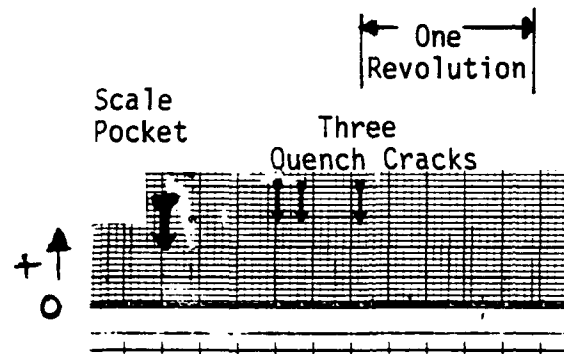
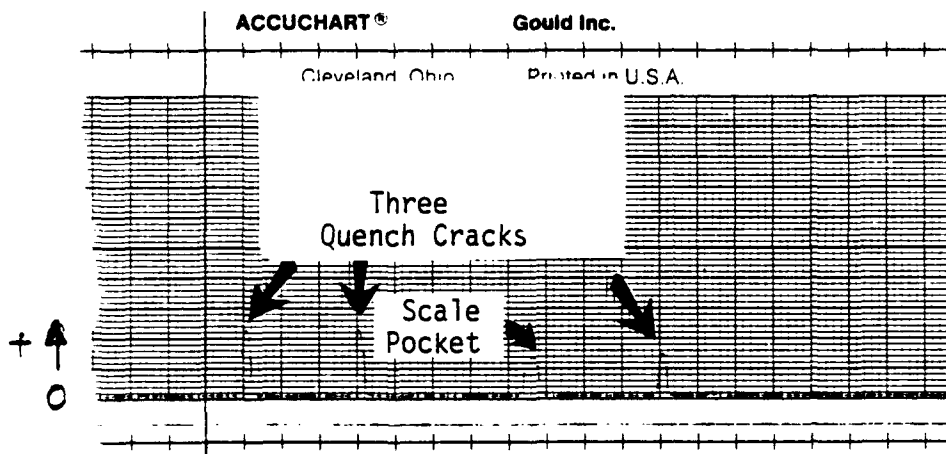
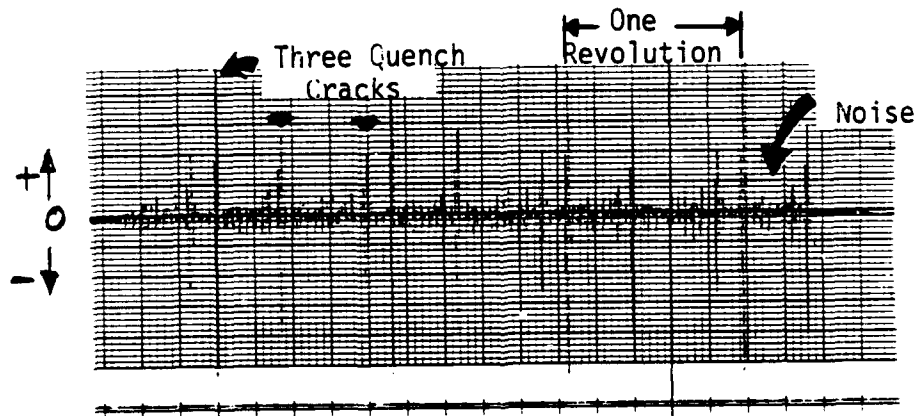
a. 3 to 30 Hz passband, chart speed 5 mm/sec.

b. 3 to 30 Hz passband, chart speed 25 mm/sec.

c. 10 to 30 Hz passband.

Figure 6. Effects of filtering on signals.

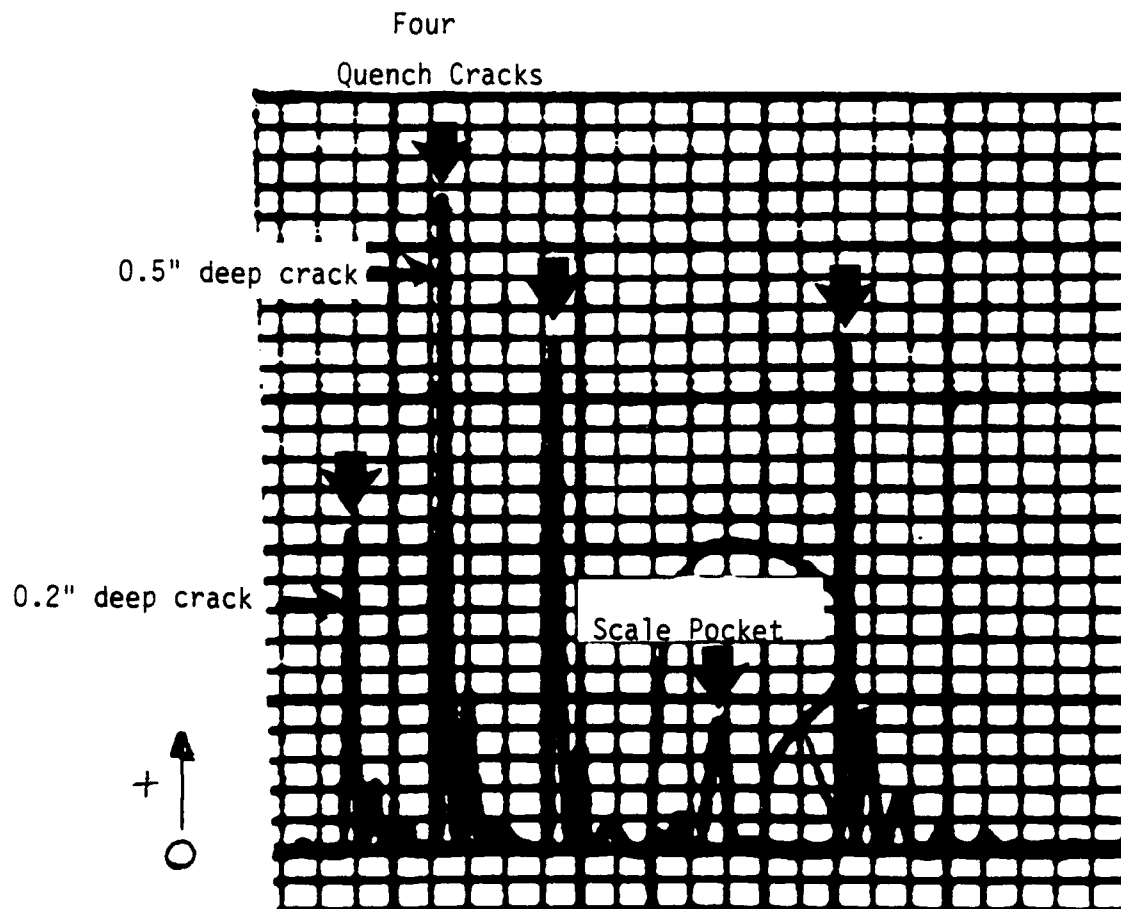
Figure 7. Comparison of crack and scale signals at different crack depths. Chart has been magnified (5X) to show the difference between the magnitude of signals from different crack depths.

Figure 7 shows the recorder trace from a tube section containing four quench cracks and one scale pocket. In this case, the difference in amplitude between the signal produced from a 0.5 and a 0.2-inch deep quench crack can be seen. Although the amplitude of the signal is not directly proportional to the crack depth, a deeper crack did produce a larger amplitude signal. Figure 8 shows the results of a test conducted using a section containing three quench cracks. The remaining surface was rough due to scaling. Despite the noise signal produced from the rough-scaled surface, the signal-to-noise ratio was still very good.

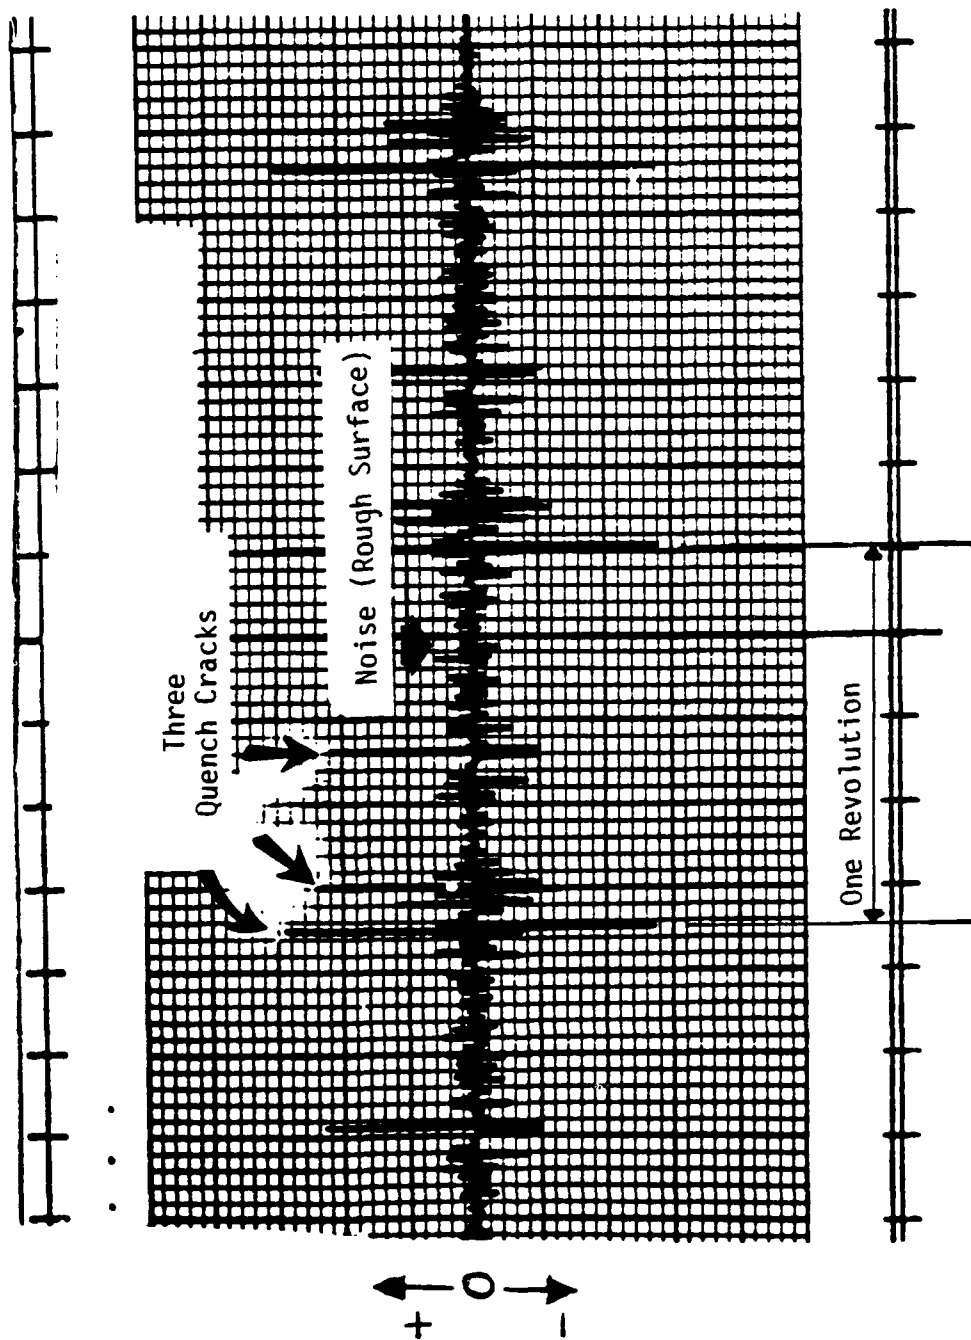
Figure 8. Three quench cracks on a rough surface.

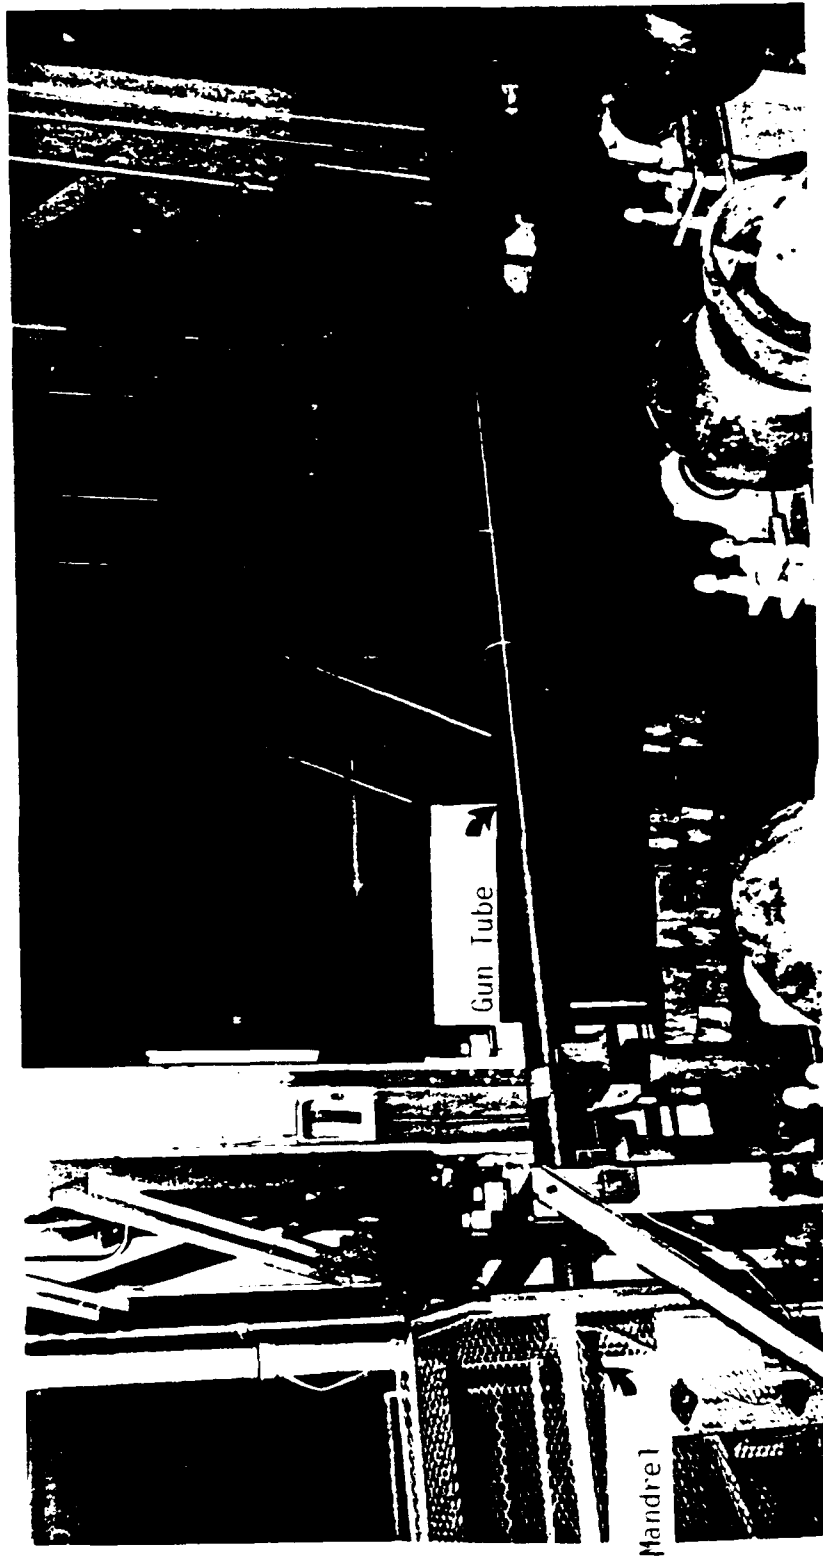
Figure 9b. Gun tube supported by adjustable stands.

The automated eddy current inspection system (Magnetic Analysis) is shown in Figures 9a and 9b. Figure 9a shows the system with the control panel in the center of the photograph. Figure 9b shows a gun tube supported by adjustable stands located at the end of the mandrel assembly. The probe assembly is mounted on the end of a mandrel driven into and out of the tube bore by an electric motor. The probe, located near the middle of the probe assembly (see Figure 10), spins at 600 rpm to provide relative motion between the tube surface and probe. Mandrel translational speed is adjustable within 1 to 10 inches per second. The signal readout is given on a strip-chart recorder (see Figure 11). Channel one gives the eddy current signal, and channel two indicates whenever channel one exceeds a threshold value. The threshold value is set at a minimum defect depth, so that channel two is triggered whenever the preset value is exceeded.

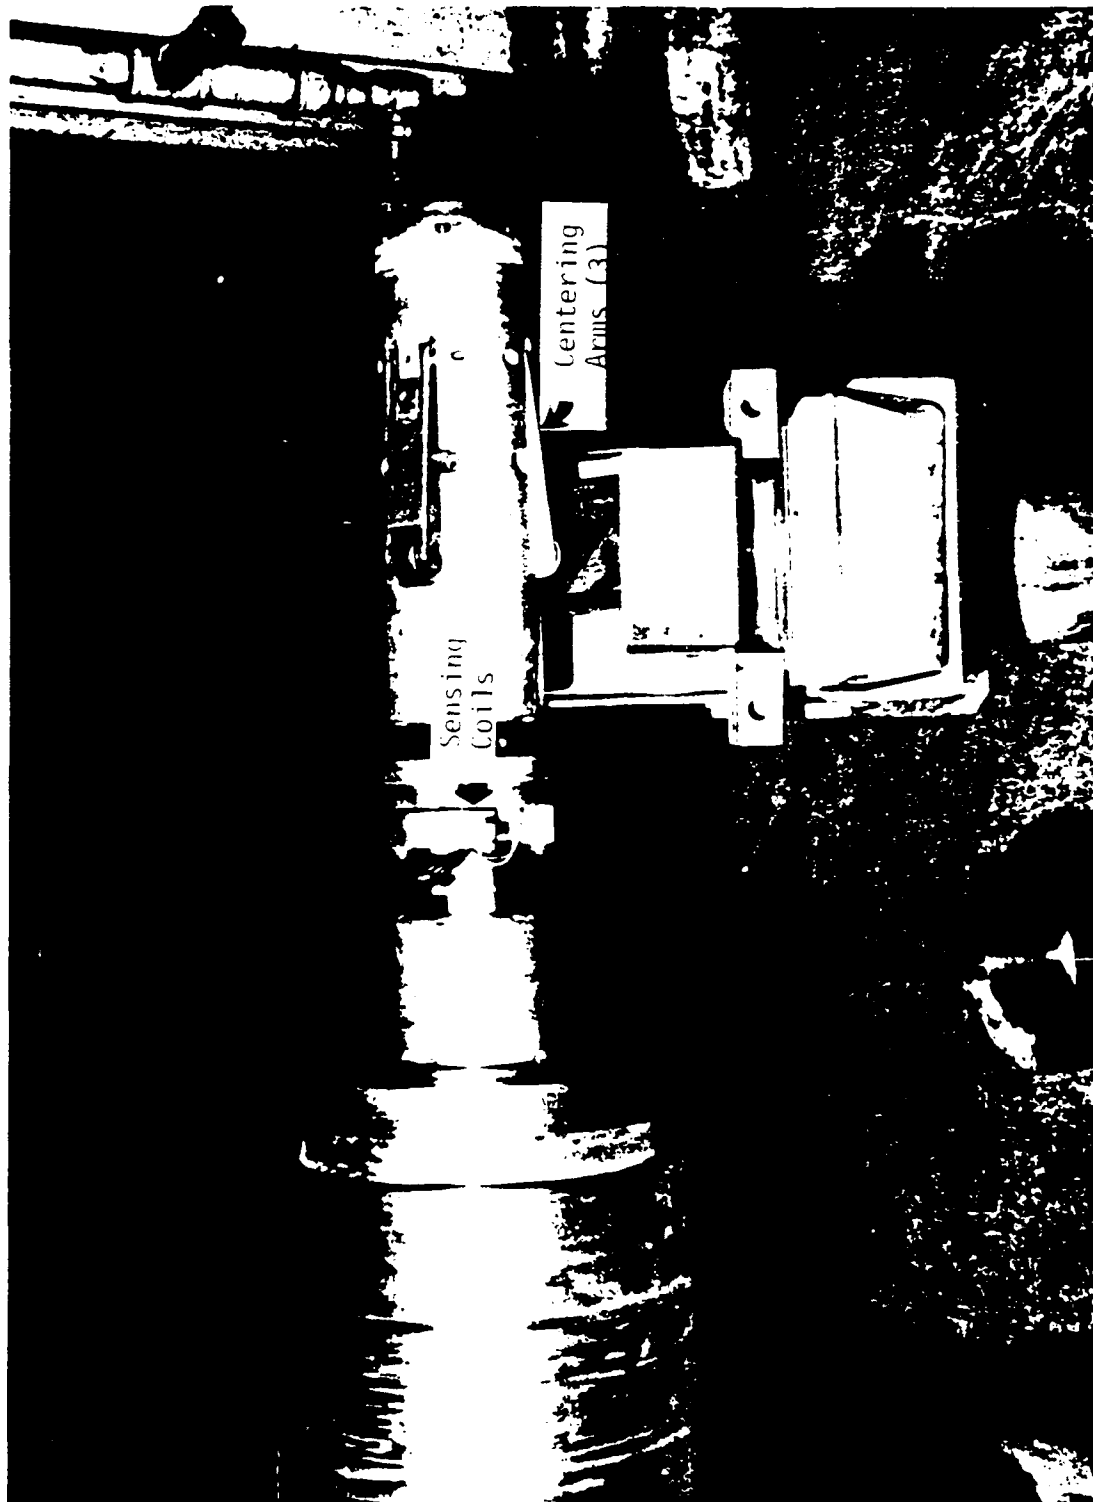
Figure 10. Probe assembly.

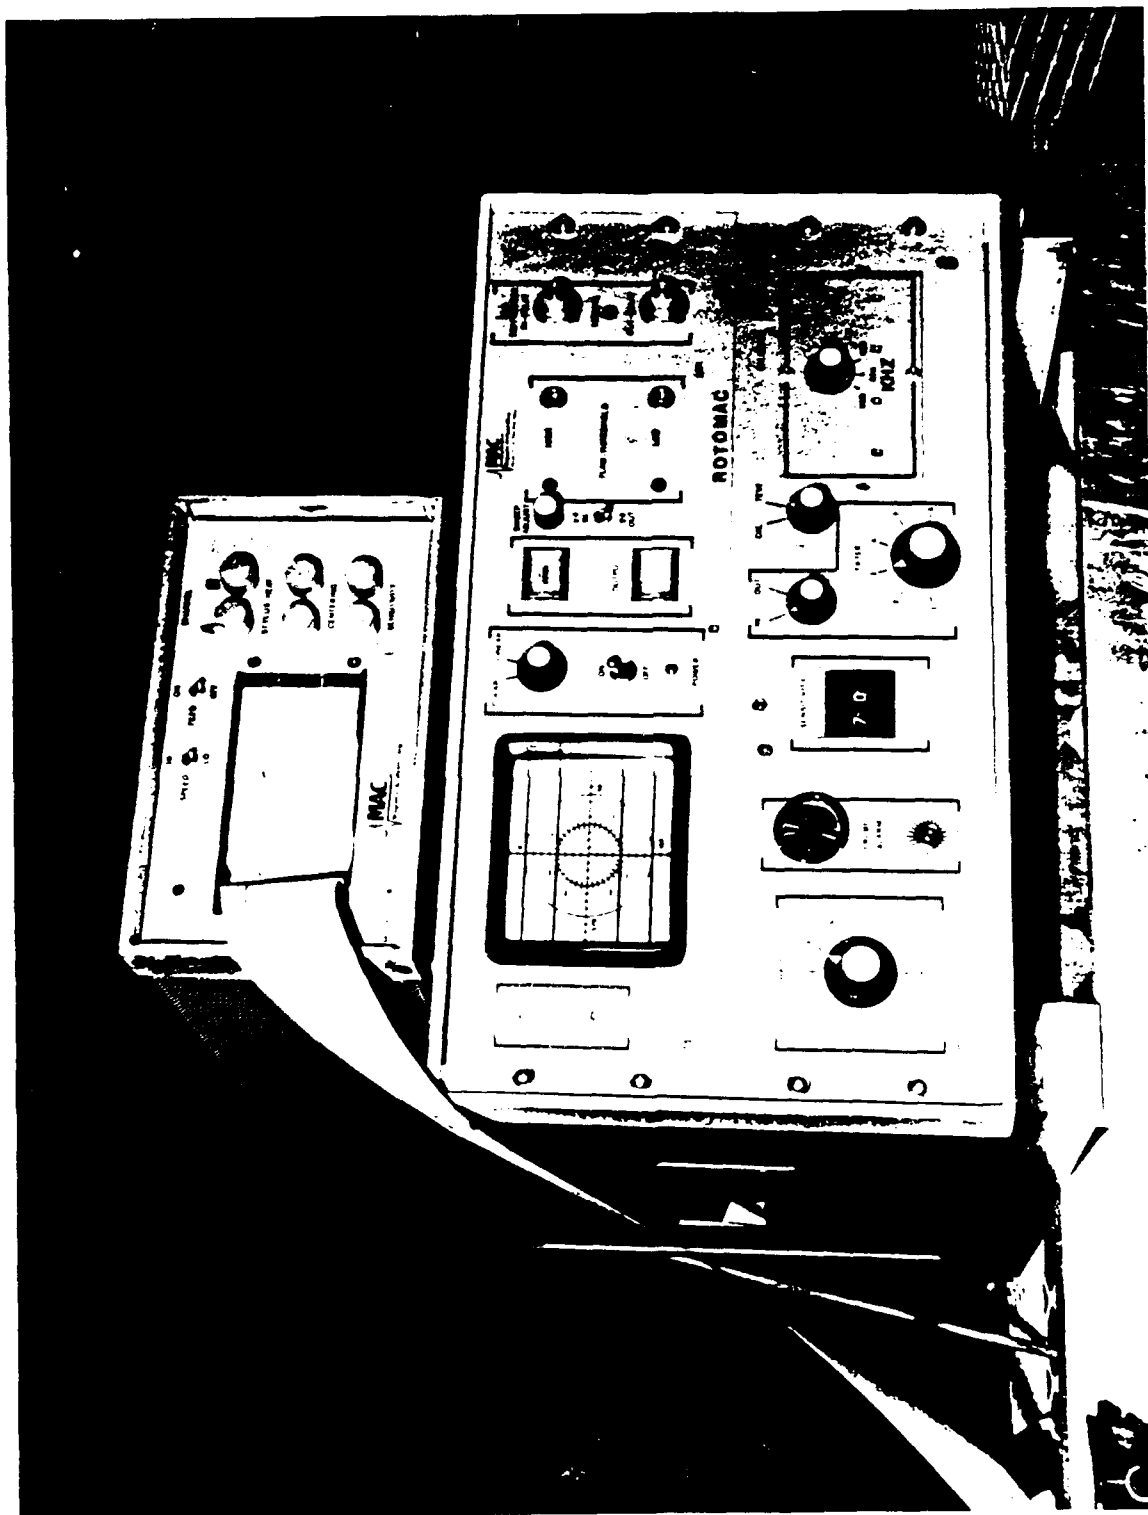
Figure 11. Strip-chart recorder and eddy current instrument.

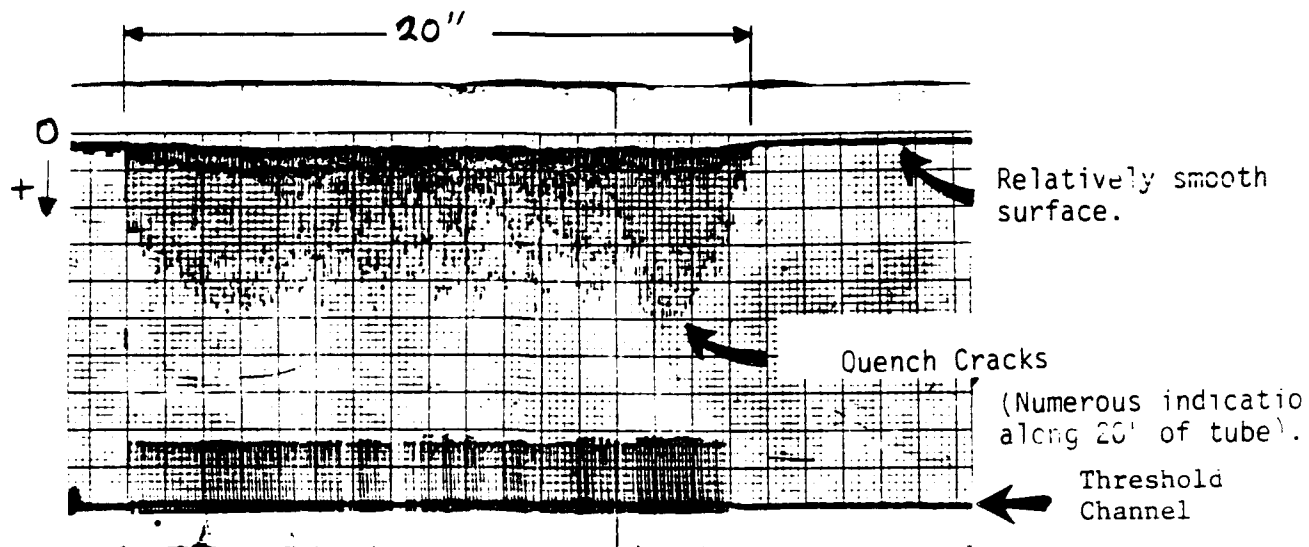
Figure 12a. Recording from a 120-mm tube containing numerous quench cracks and no scale pockets using the Magnetic Analysis System.

Figure 12a shows the recorder trace obtained from the inspection of a 120-mm tube. The upper trace (channel one) is the signal from the eddy current sensor, and the bottom trace (channel two) is triggered whenever the amplitude of channel one exceeds the threshold value. This tube contained numerous quench cracks located from the breech end to six feet away. In this case, the signal obtained from the quench cracks is quite obvious. This tube, although in the as-forged state, has an ID surface without loose scale. Figure 12b shows the trace obtained from a 155-mm tube without quench cracks, but it did have an ID surface with loose scale on the breech end of the tube. The indication from scale pockets (see Figure 13) is indistinguishable from the quench crack indications.

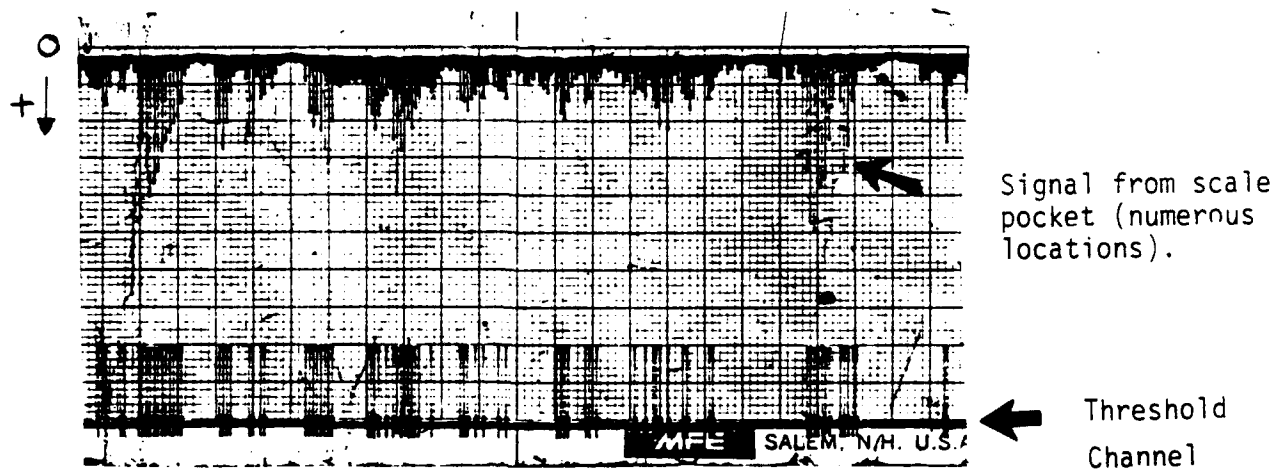
Figure 12b. Recording from a 120-mm tube with scale pockets and no quench cracks using the Magnetic Analysis System.

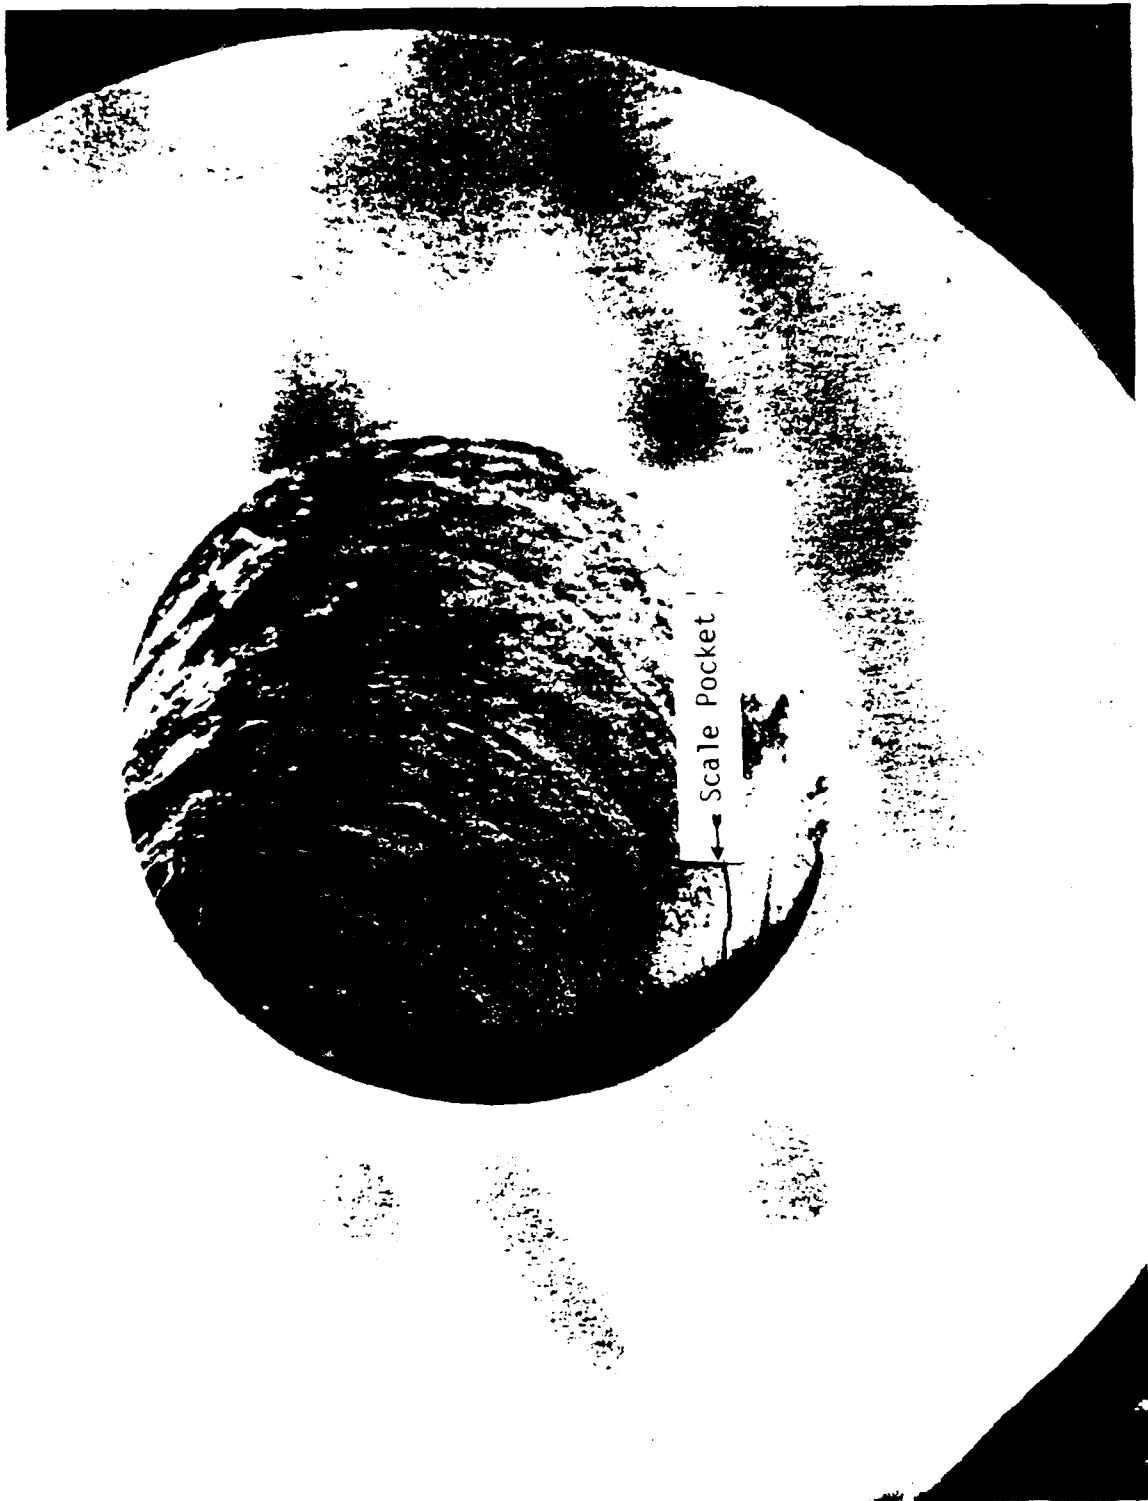
Figure 13. Scale pocket of a 155-mm tube.

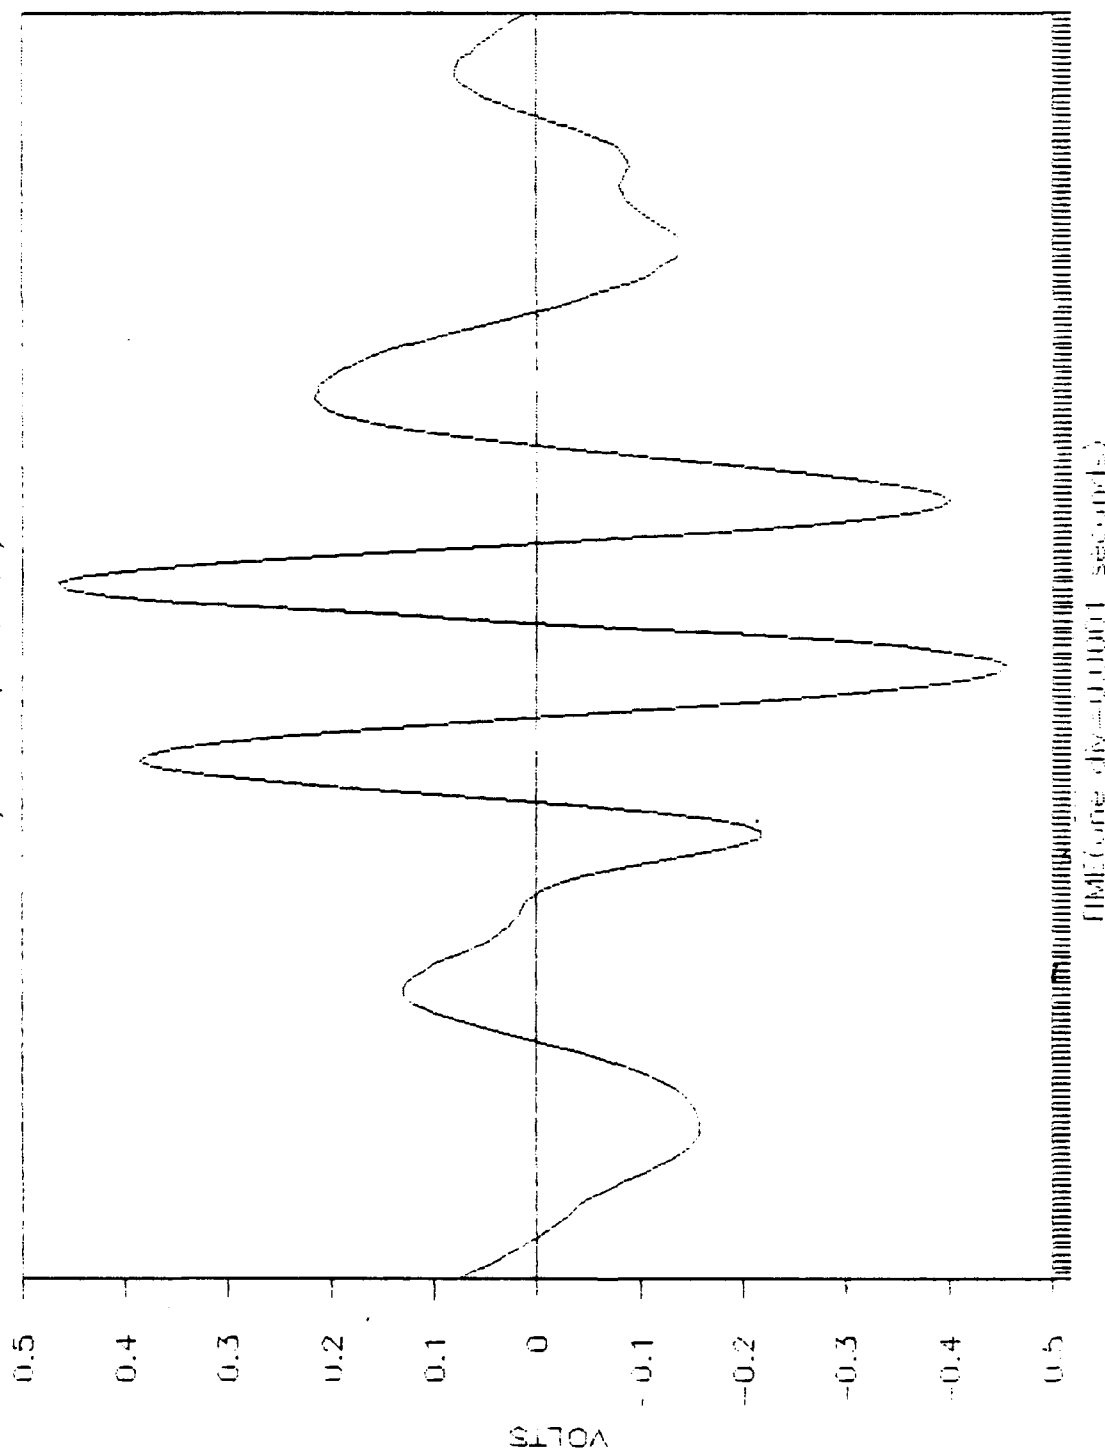
QUENCH CRACKS (120mm #1890)

F₀ filter, 200kHz, sens=62, sr=10000Hz

Figure 14. Signals obtained from quench cracks digitized at 10,000 Hz.

In an attempt to examine the signals more closely, those obtained from quench cracks and scale pockets were digitized at a sampling rate of 10,000 Hz. The results are shown in Figures 14 and 15, respectively. Unfortunately, this closer examination of the signals did not reveal a discernible difference between the two signals. At that point, a decision was made to concentrate on preparing the system to inspect tubes after rough-machining in the before-swage condition. Tubes in this condition have a machined ID surface, therefore the problem of scale pockets encountered with the surface condition on as-forged tubes would not be present. Further attempts to develop methods capable of discriminating between scale pocket and defect signals require funding and efforts in excess of this project.
